# Five-Fatality Highrise Office Building Fire

Atlanta, Georgia

USFA-TR-033/June 1989

This is Report 033 of the Major Fires Investigation Project conducted by TriData Corporation under contract EMW-88-C-2649 to the United States Fire Administration, Federal Emergency Management Agency.

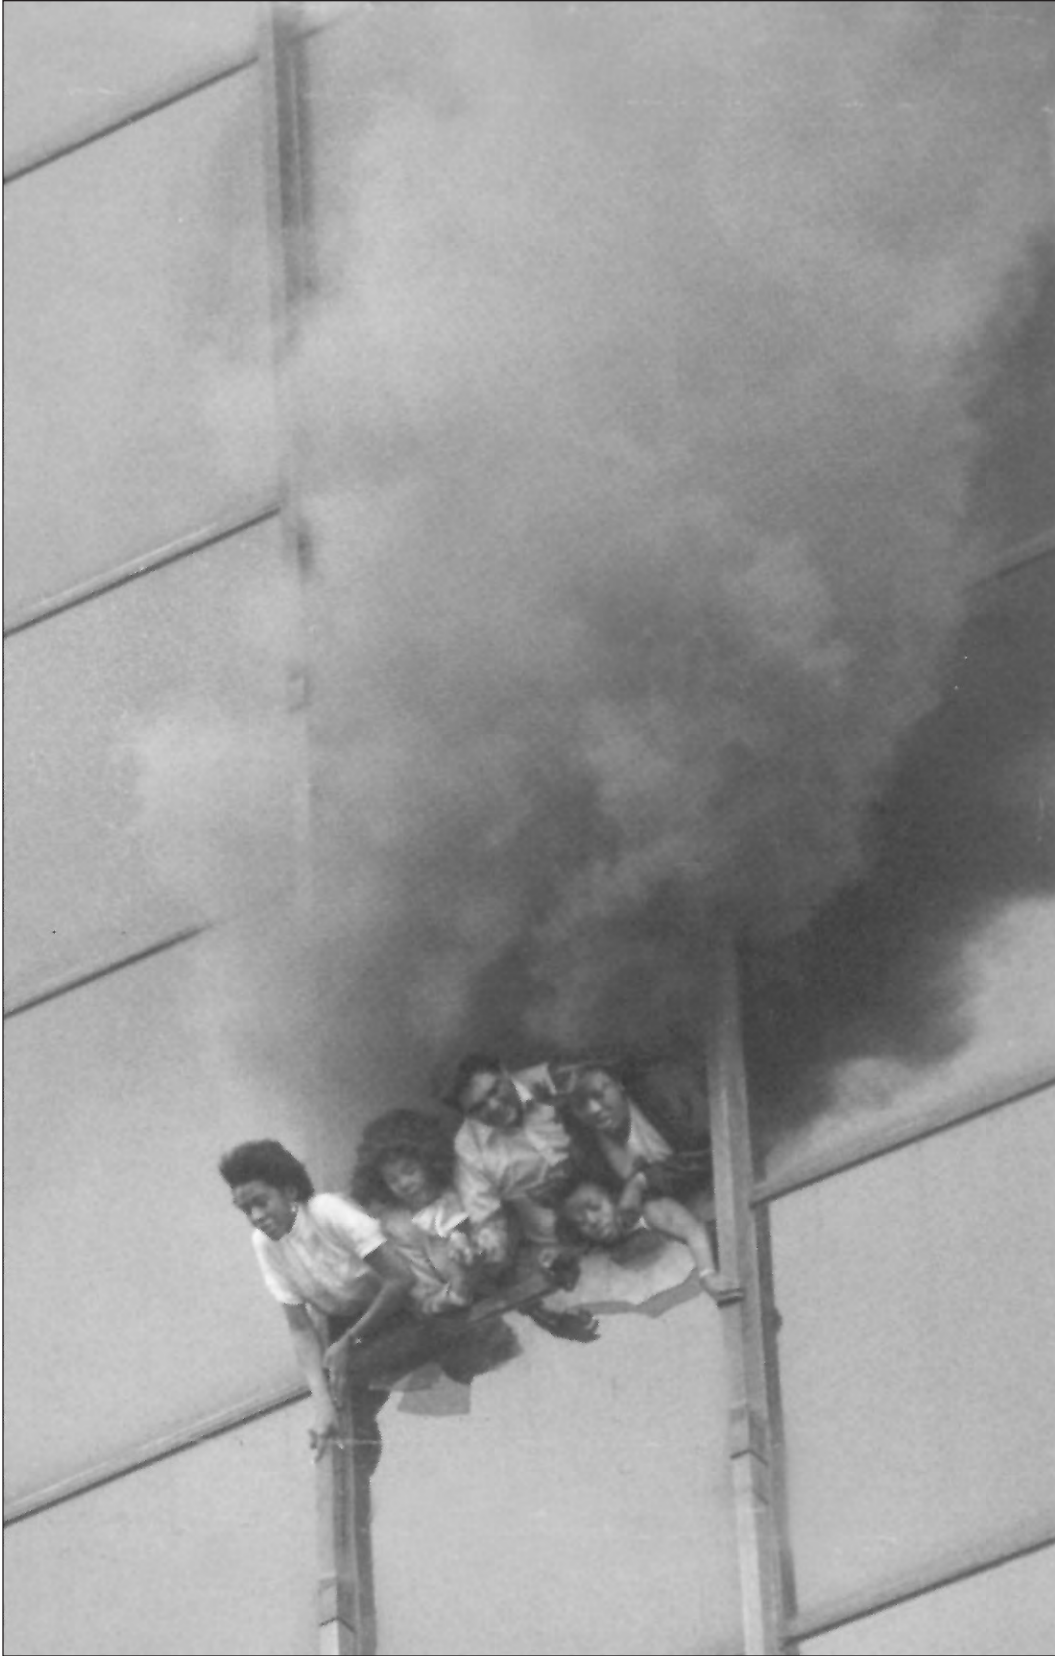
2. Victims awaiting rescue on south side of building, sixth floor.

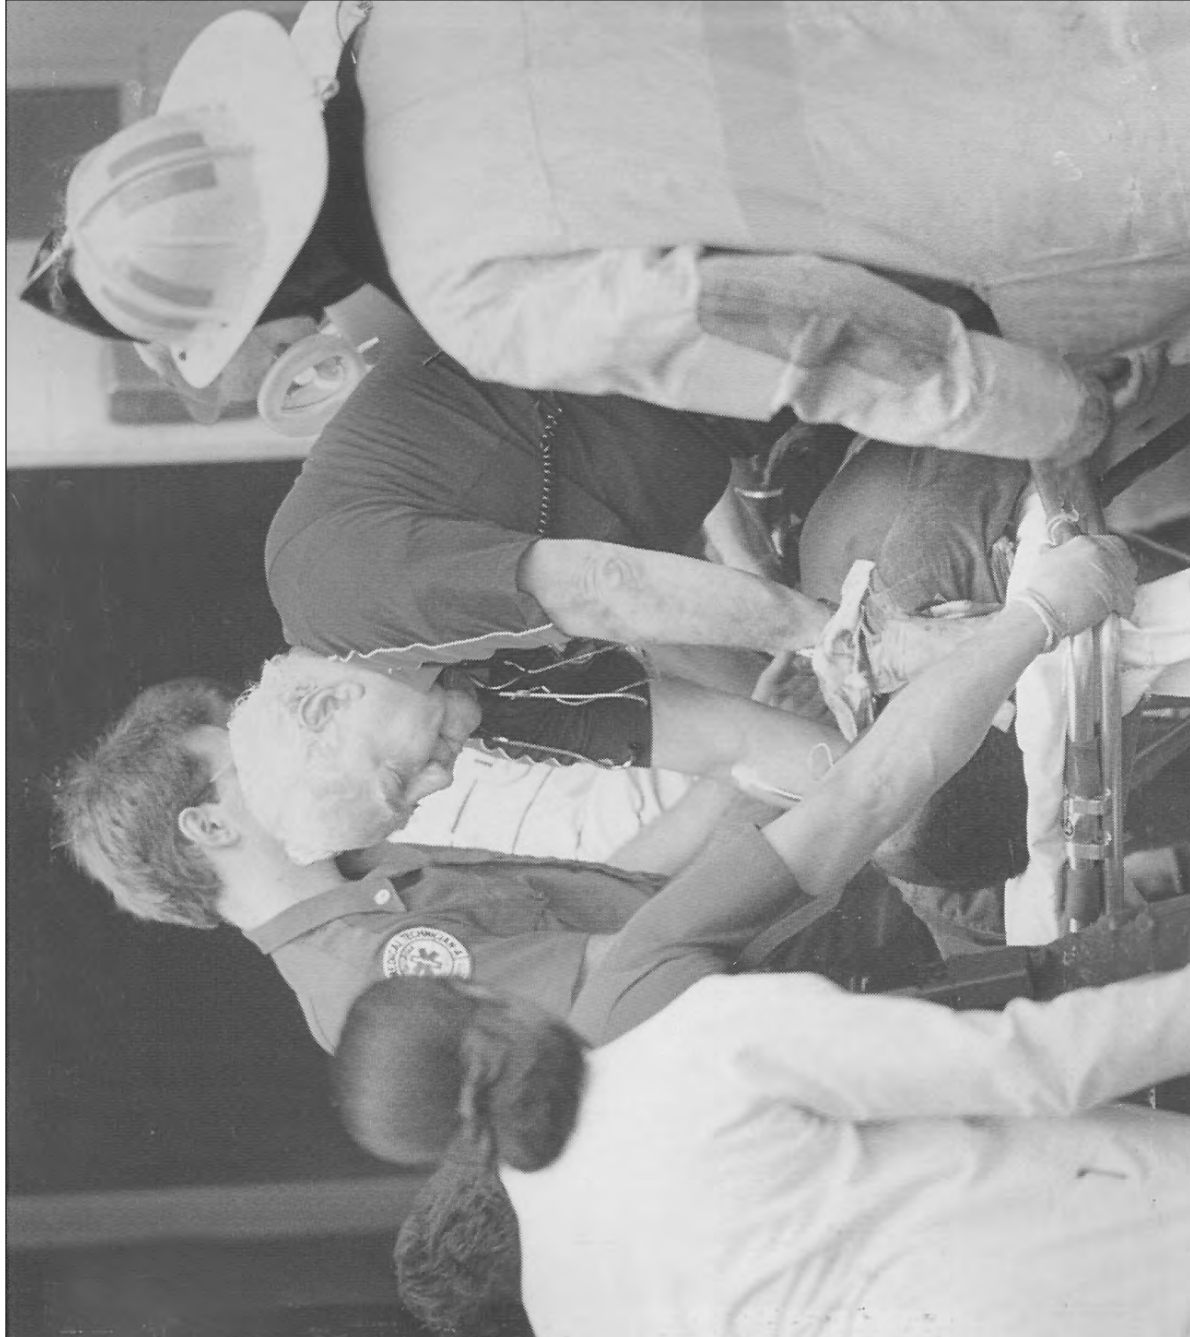
5. Resuscitation attempt on victim removed from rear of sixth floor.

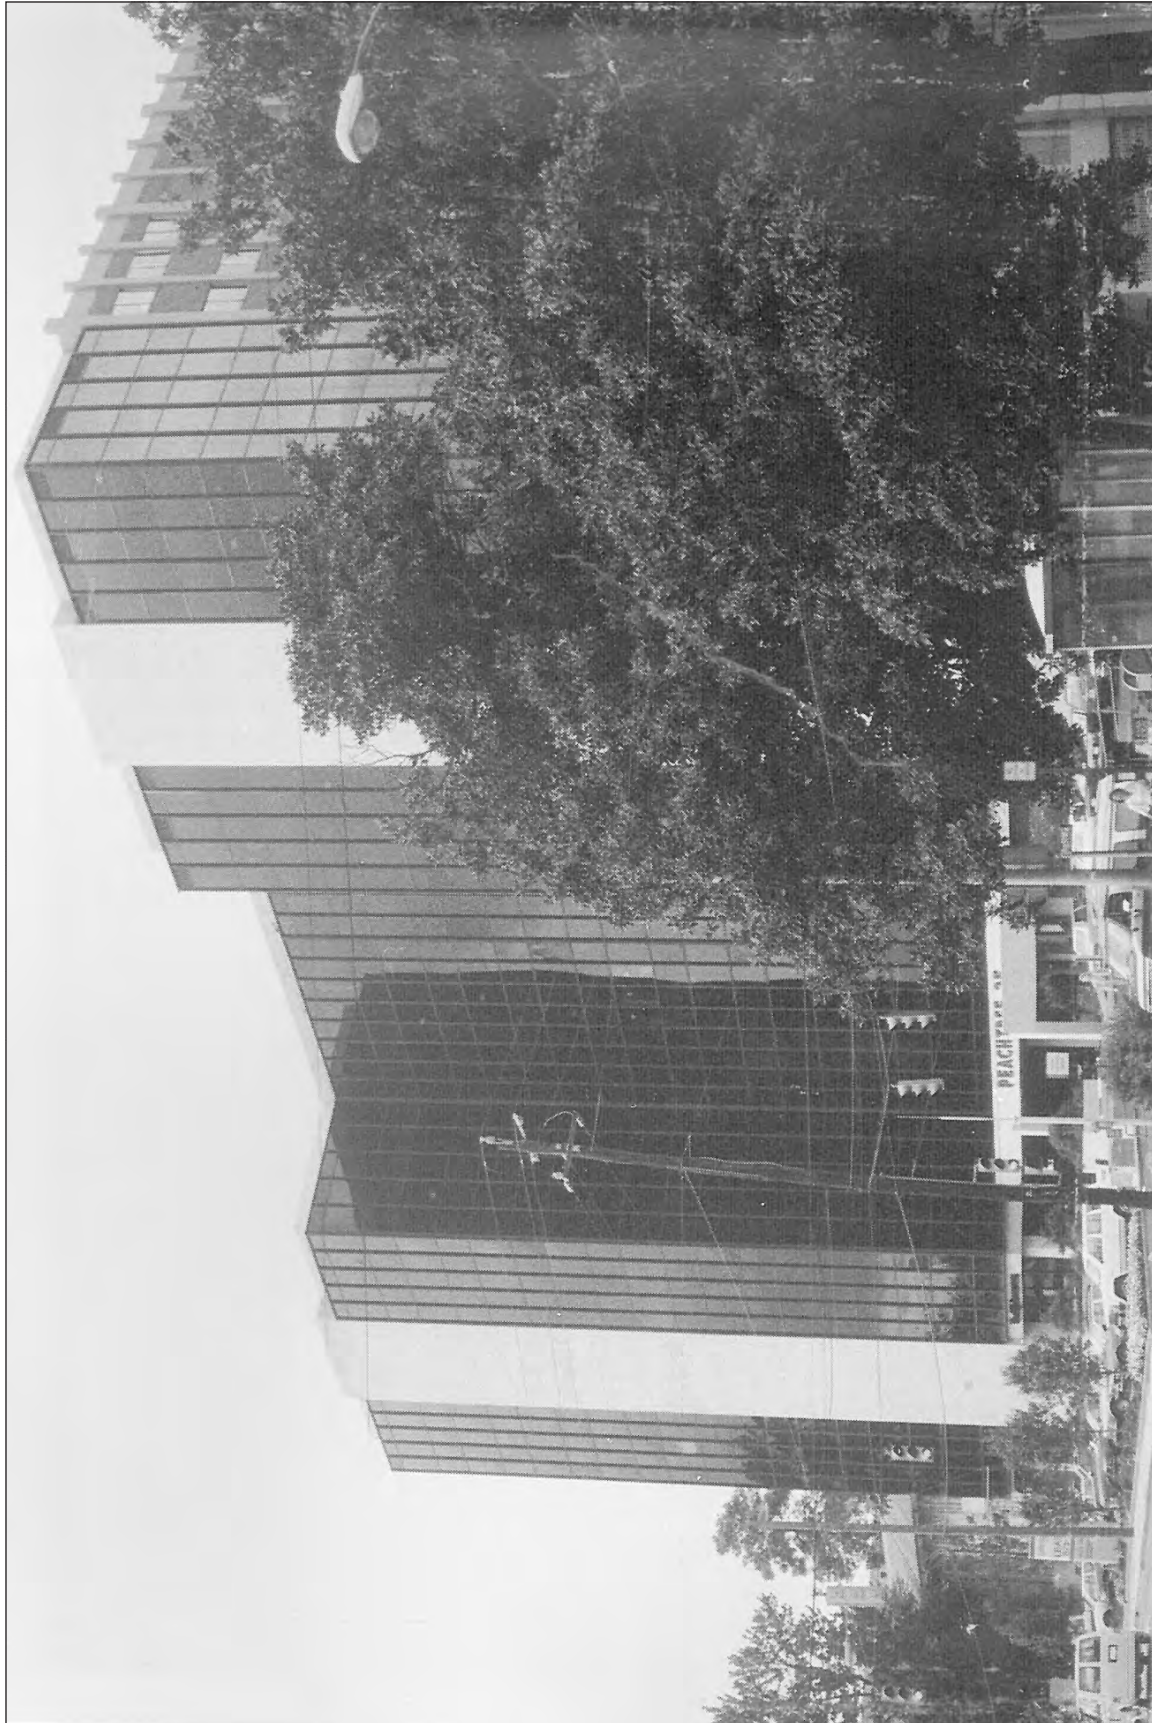
7. Front of building.

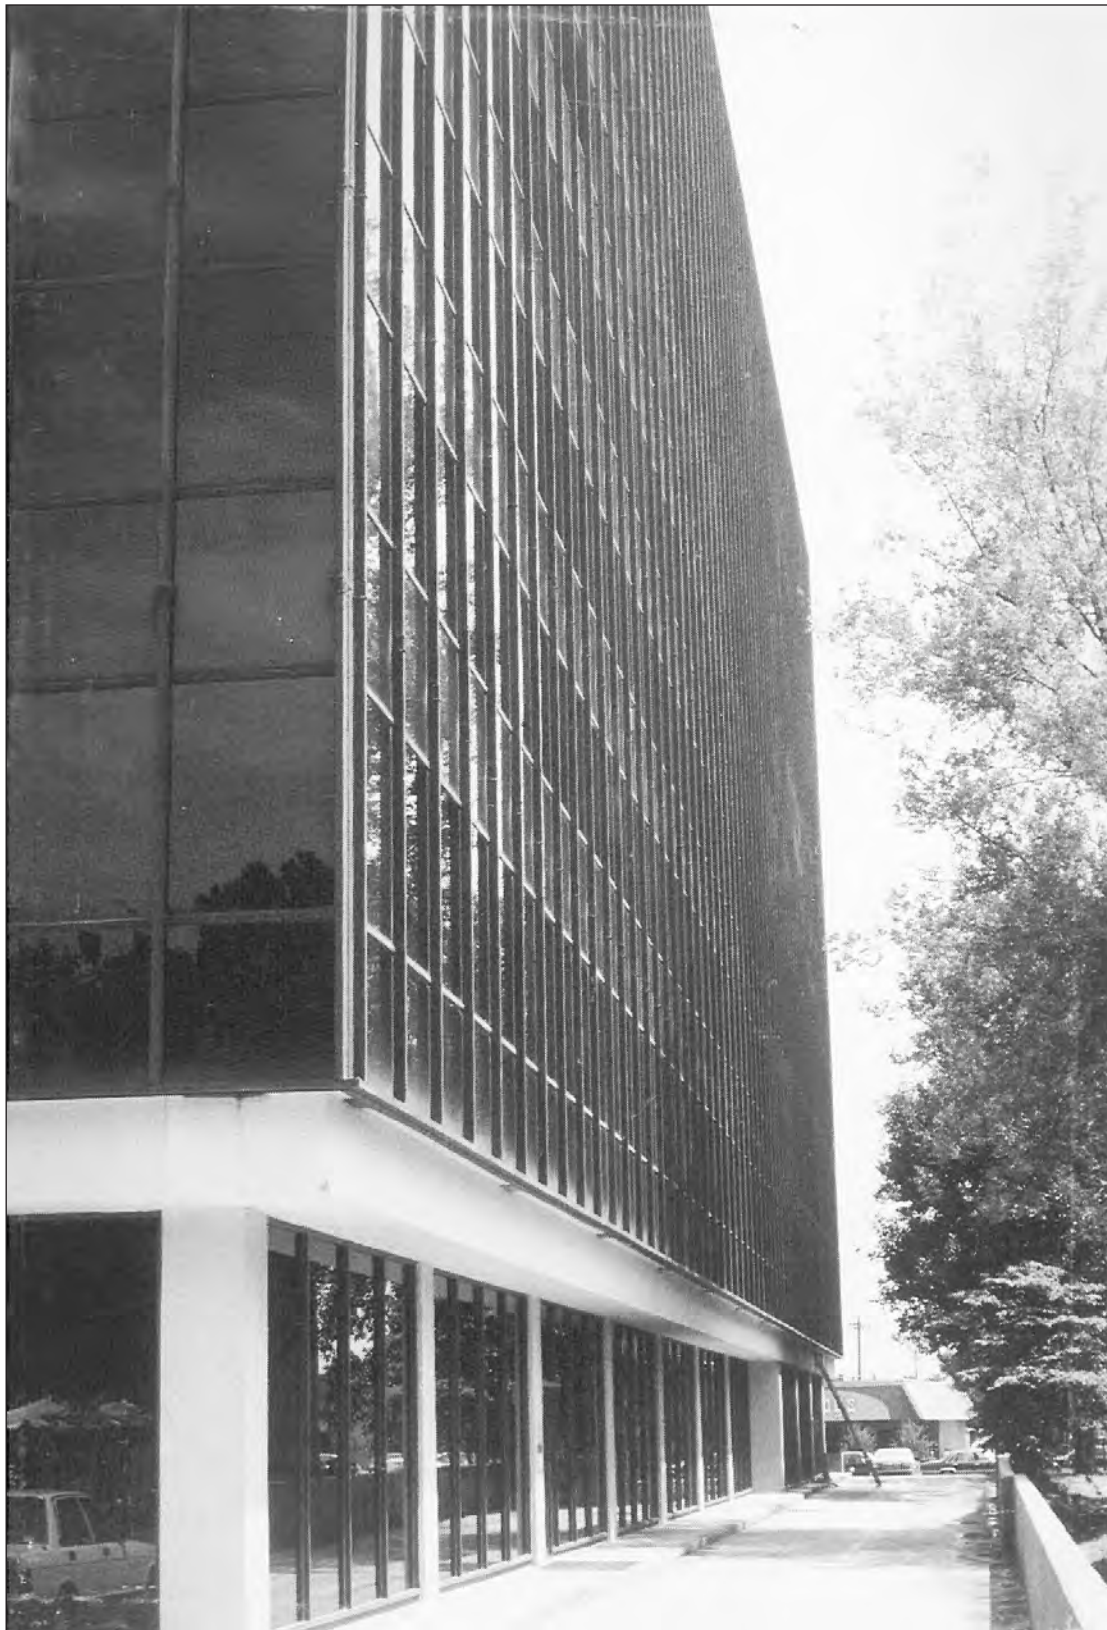
**9. South side of building, showing driveway, looking toward front of building (Peachtree Street). Woman who jumped landed on this driveway.**

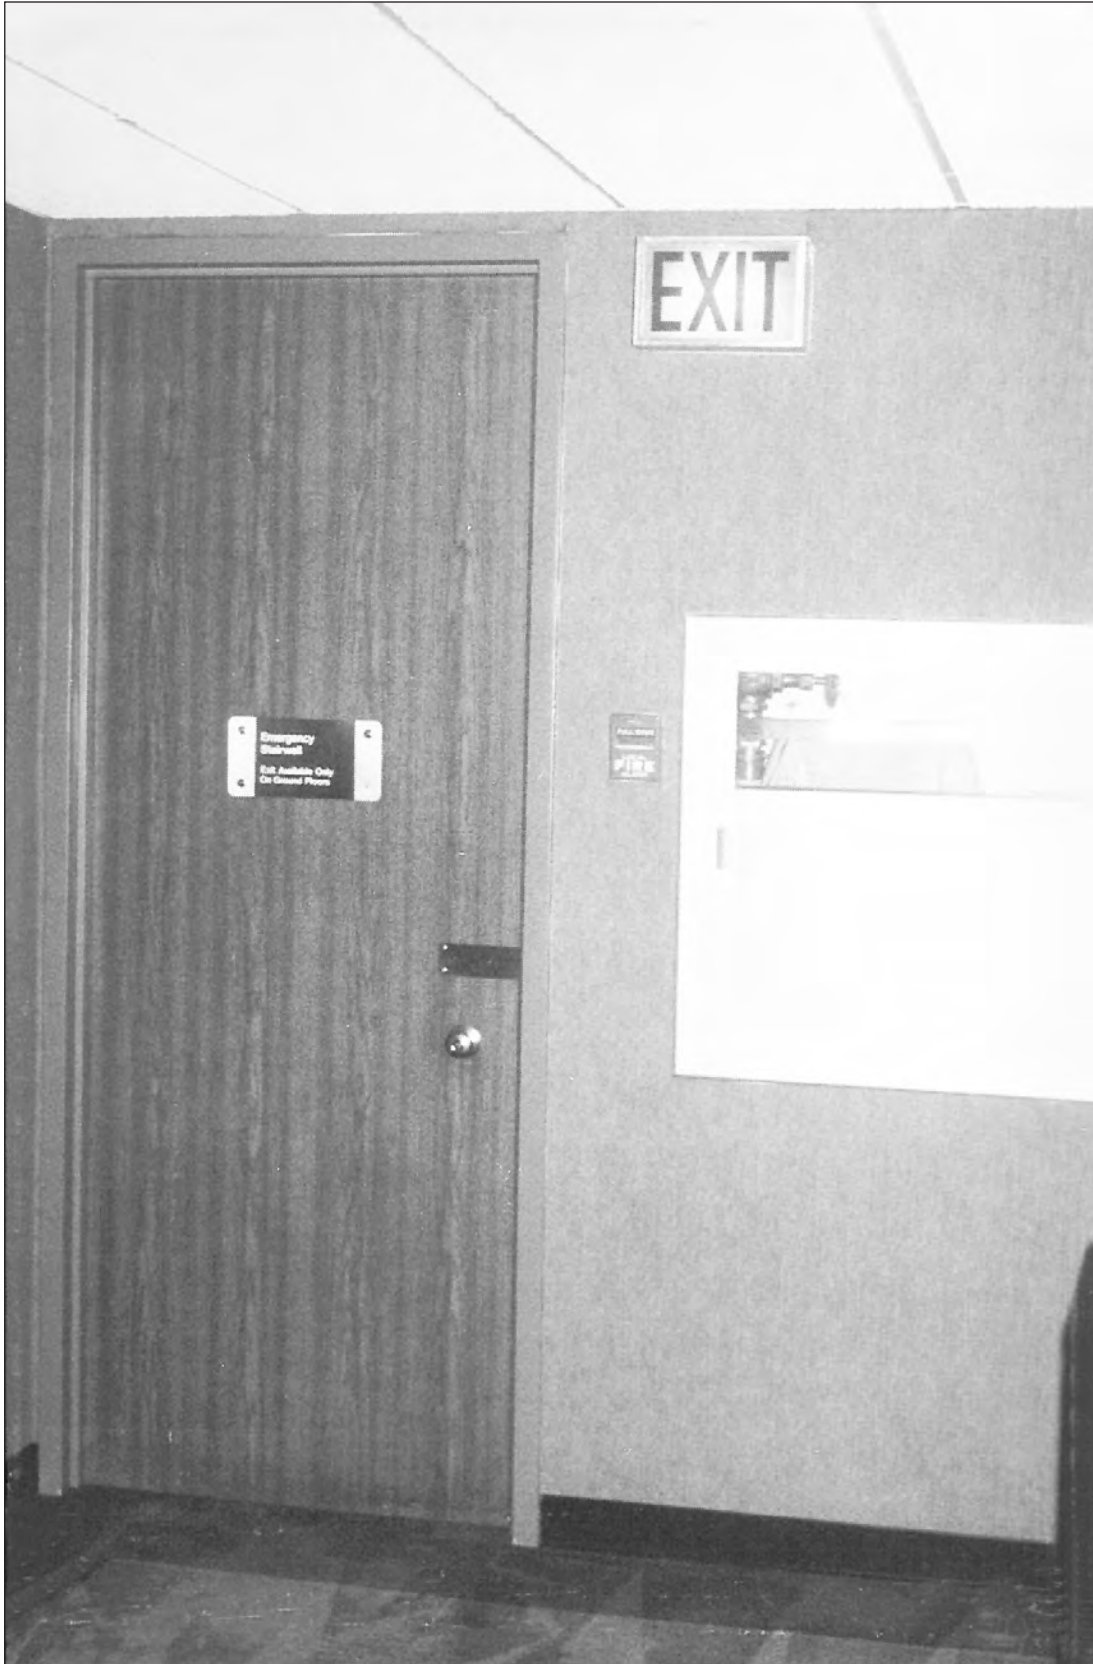
| Issues | Comments |
|---|---|
| Arrangement of Exits | The electric closet was located such that when the fire started, access to both exits was blocked for several offices that were located at the end of a dead-end corridor. |

10. Typical exit arrangement at rear of floor, South Tower.

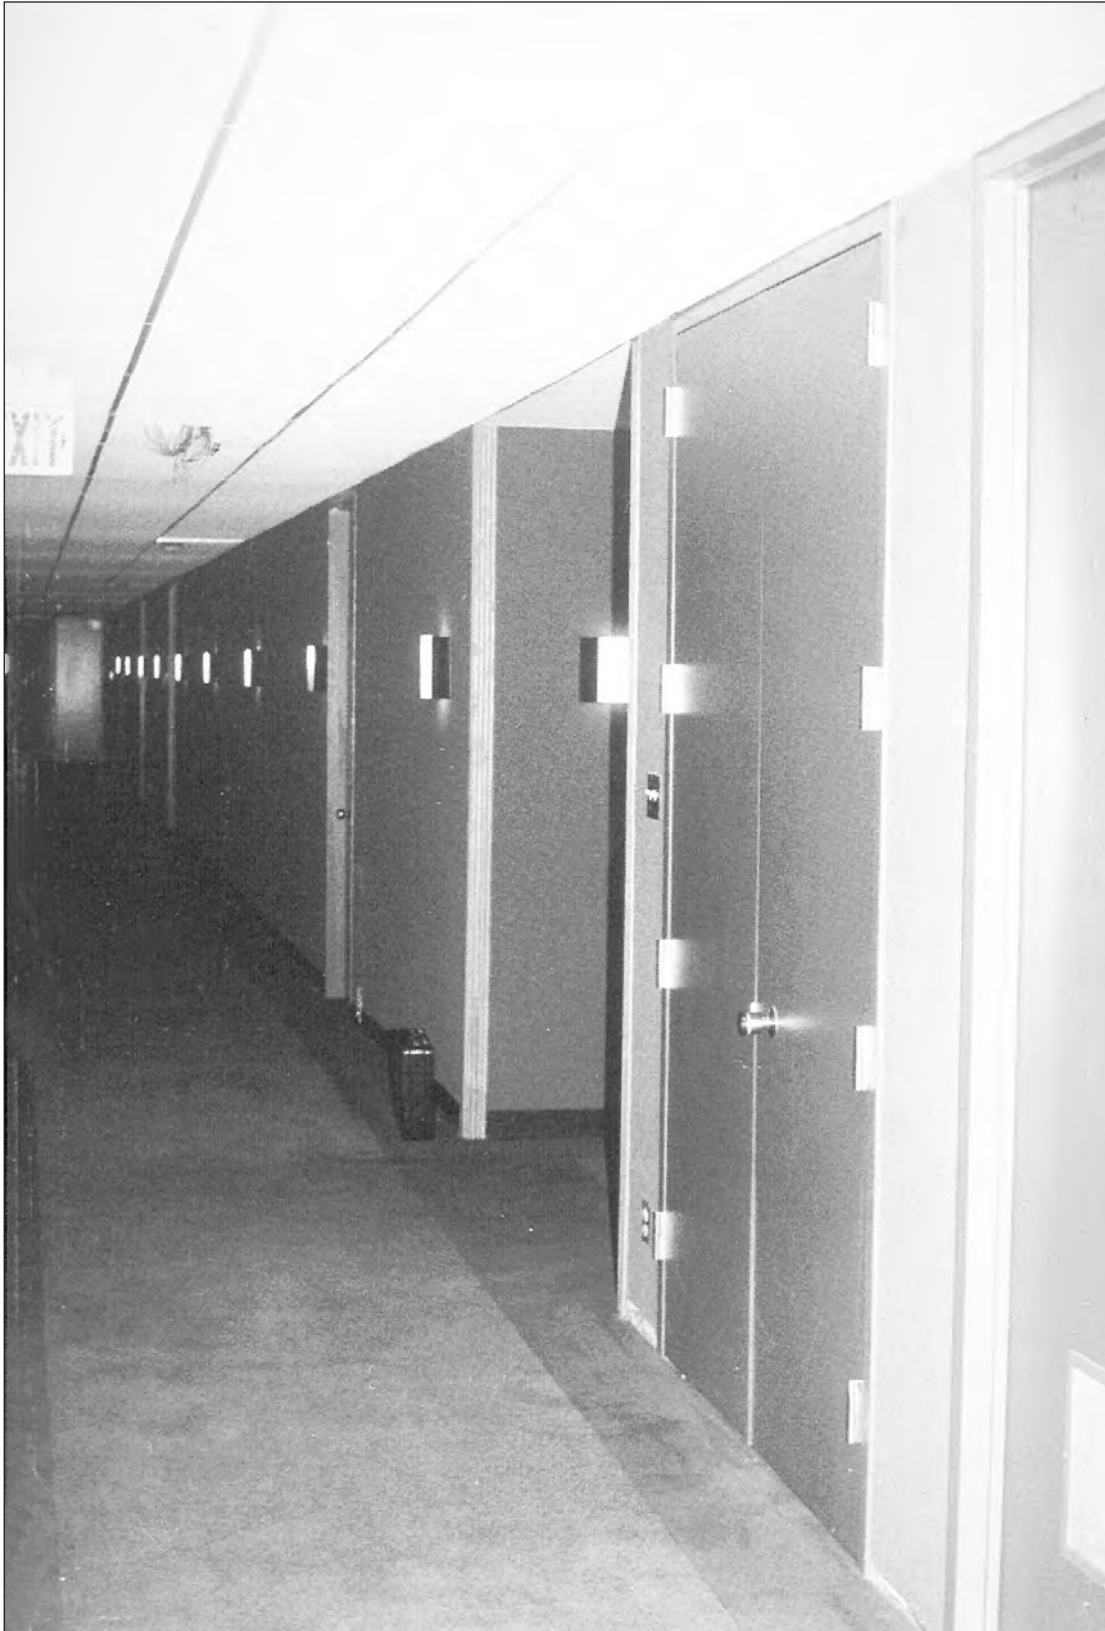
The electric closet where the fire started opened directly onto the exit corridor. When the fire erupted, it immediately blocked the corridor, keeping most victims away from the two exits serving the floor.

11. Fifth floor corridor looking toward rear of building. Electrical closet is in foreground. Elevator lobby and front stairway are around the corner to right.

**6. Hazardous areas should be separated from the exit corridor by fire resistive construction.**

Separation of hazardous areas such as electrical rooms should be considered as a retrofit item in structures where a fire or similar situation could be expected to cause an immediate threat to the ability of occupants to reach exits.
